**Flood Control Project Maintenance
Levee Inspections
LMA District Cover Sheet
Spring 2009 Levee Inspection Results**

San Joaquin County Flood Control District

Spring 2009 Levee Inspection Results

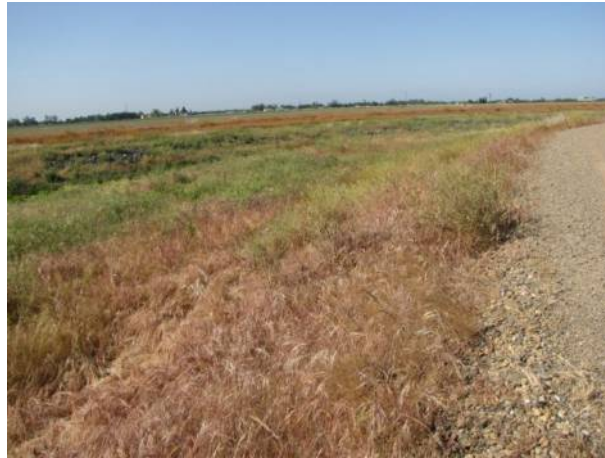
Levee Mile Report Line	1
Start Levee Mile	0.00
End Levee Mile	0.35
Location	Water Side
Category	Earthen Levee
Item	Vegetation
Remove/mow grass & vegetation along top 20' of waterward slope of levee.

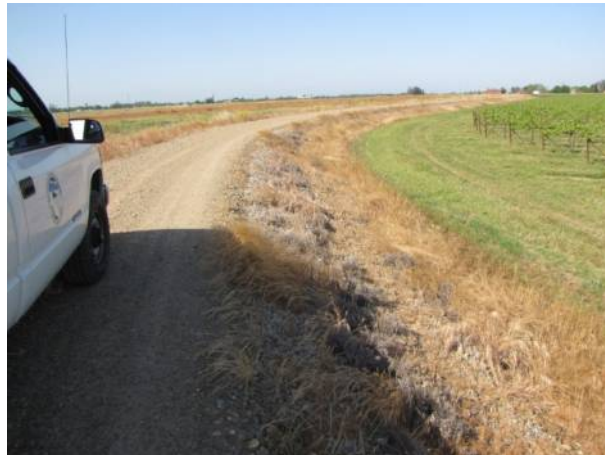
Levee Mile Report Line	2
Start Levee Mile	0.00
End Levee Mile	0.35
Location	Land Side
Category	Earthen Levee
Item	Vegetation
Remove/mow grass & vegetation along landward slope of levee and within 10' of the toe.

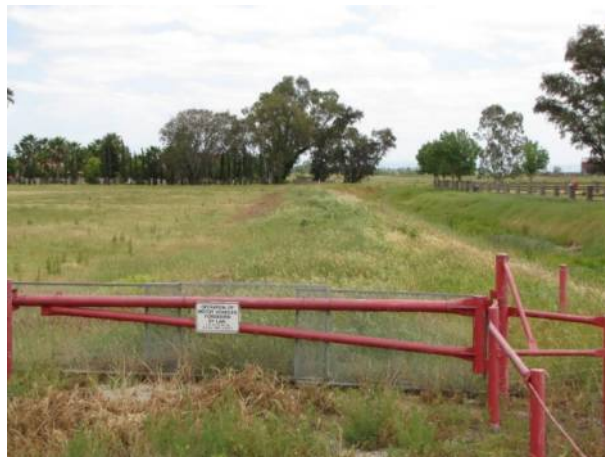
Levee Mile Report Line	6
Start Levee Mile	1.40
End Levee Mile	1.42
Location	Crown
Category	Earthen Levee
Item	Vegetation
Remove/mow grass & vegetation along crown of levee/access road.

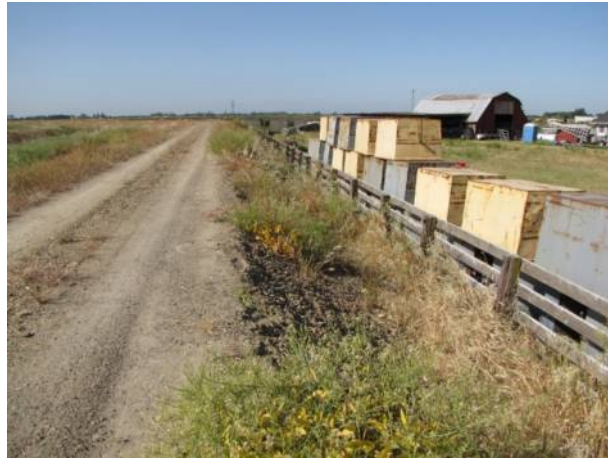
Levee Mile Report Line	1
Start Levee Mile	0.00
End Levee Mile	0.45
Location	Land Side
Category	Earthen Levee
Item	Vegetation
Remove/mow grass & vegetation along landward slope of levee and within 10' of the toe.

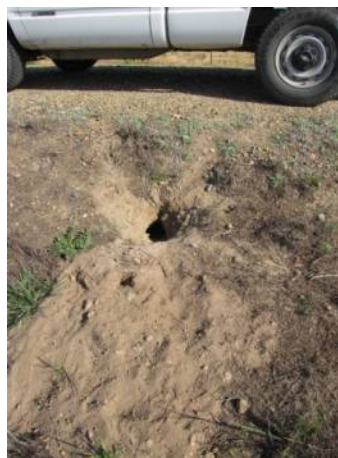
Levee Mile Report Line	6
Start Levee Mile	3.09
End Levee Mile	3.09
Location	Water Side
Category	Earthen Levee
Item	Animal Control

Exterminate the rodents and backfill and compact all rodent holes.

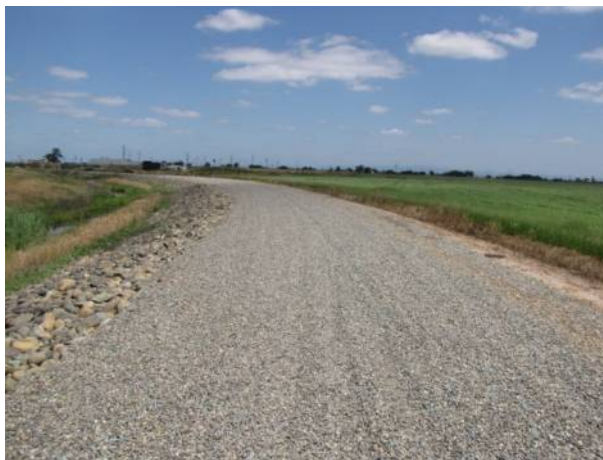
Levee Mile Report Line	3
Start Levee Mile	1.79
End Levee Mile	1.79
Location	Crown
Category	Earthen Levee
Item	Crown Surface / Depressions / Rutting
Example of well maintained road and levee on this unit.

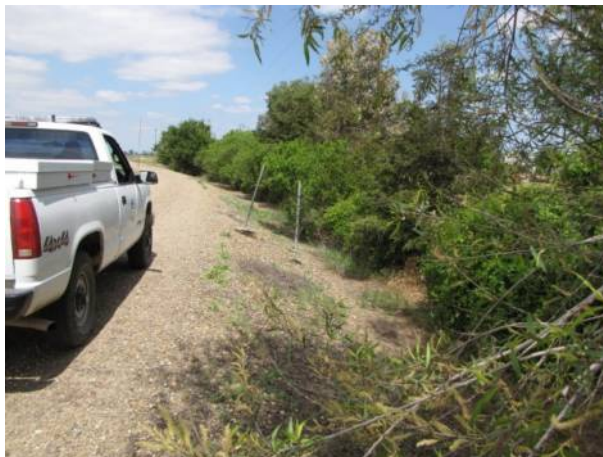
Levee Mile Report Line	4
Start Levee Mile	2.42
End Levee Mile	2.44
Location	Land Side
Category	Earthen Levee
Item	Encroachments
Landscaping on landward levee slope and within 10' of the toe.

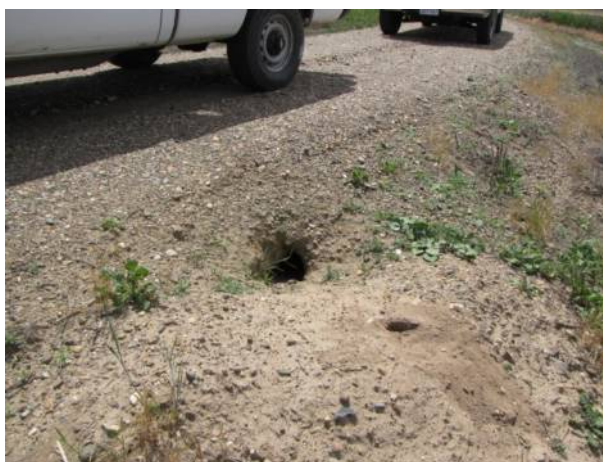
Levee Mile Report Line	5
Start Levee Mile	2.65
End Levee Mile	2.65
Location	Water Side
Category	Earthen Levee
Item	Animal Control
Example rodent hole on waterward side of levee. Backfill and compact all rodent holes.

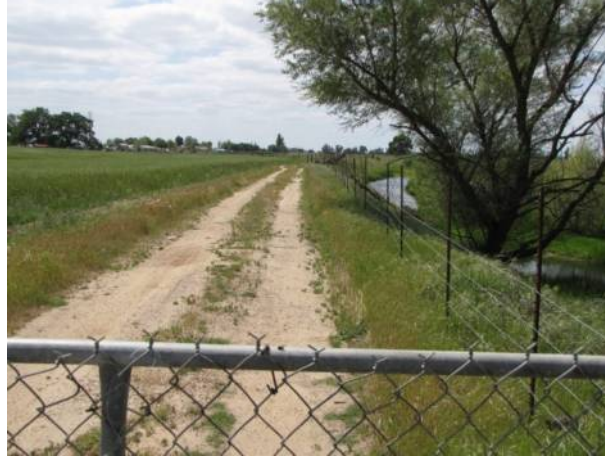
Levee Mile Report Line	7
Start Levee Mile	3.53
End Levee Mile	3.92
Location	Crown
Category	Earthen Levee
Item	Encroachments

Fence along waterward sholder and crown of access road. The road cannot be driven through as the fence blocks access. The gate does not have a county key on the gate.

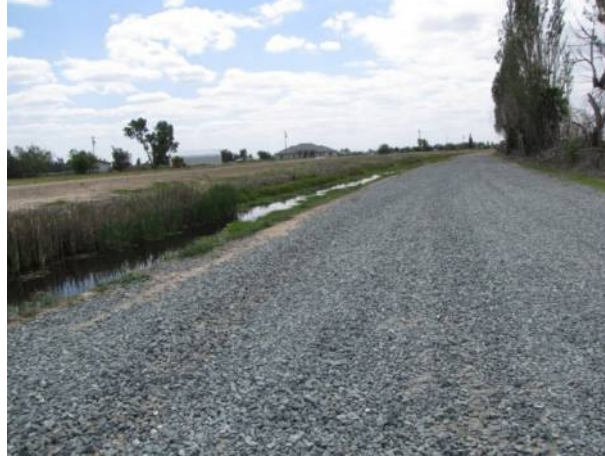
Levee Mile Report Line	1
Start Levee Mile	0.53
End Levee Mile	0.53
Location	Crown
Category	Earthen Levee
Item	Crown Surface / Depressions / Rutting

Example of rock placed on crown of levee. This unit is well maintained.

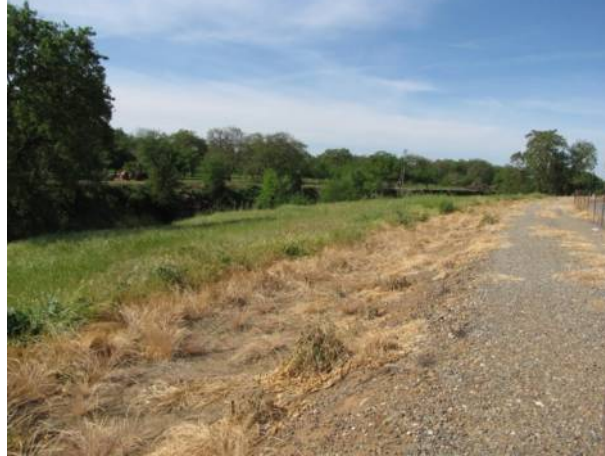
Levee Mile Report Line	2
Start Levee Mile	0.29
End Levee Mile	1.93
Location	Water Side
Category	Earthen Levee
Item	Vegetation
Mow grass & vegetation on waterside of levee along the top 20' at LM 0.29 to LM 1.93.

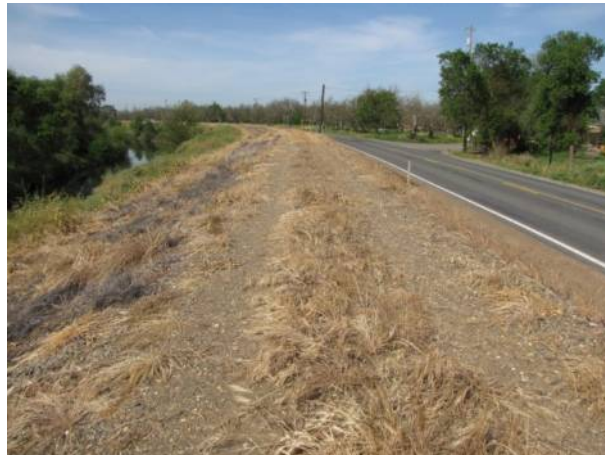
Levee Mile Report Line	3
Start Levee Mile	0.76
End Levee Mile	1.22
Location	Crown
Category	Earthen Levee
Item	Vegetation
Mow grass & vegetation along crown of the levee from LM 0.76 to LM 1.22.

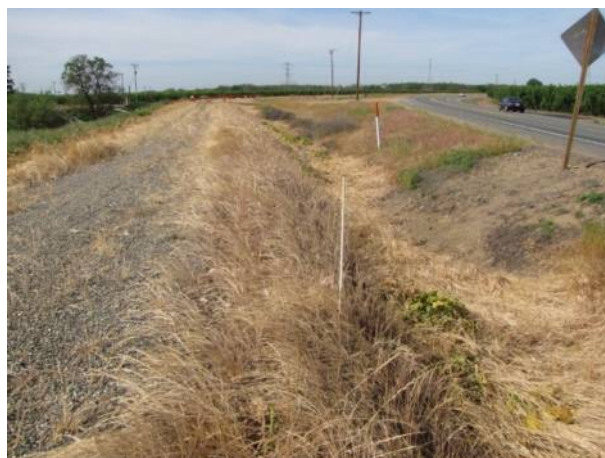
Levee Mile Report Line	4
Start Levee Mile	1.16
End Levee Mile	2.12
Location	Land Side
Category	Earthen Levee
Item	Vegetation
Mow grass & vegetation along landward slope of levee within 10' of the toe from LM 1.16 to LM 2.12.

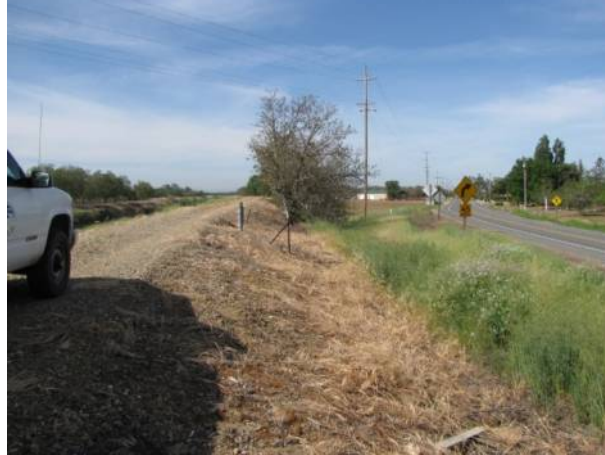
Levee Mile Report Line	6
Start Levee Mile	2.34
End Levee Mile	2.48
Location	Land Side
Category	Earthen Levee
Item	Vegetation
Mow grass & vegetation along landward slope of levee within 10' of levee toe from LM 2.34 to LM 2.48.

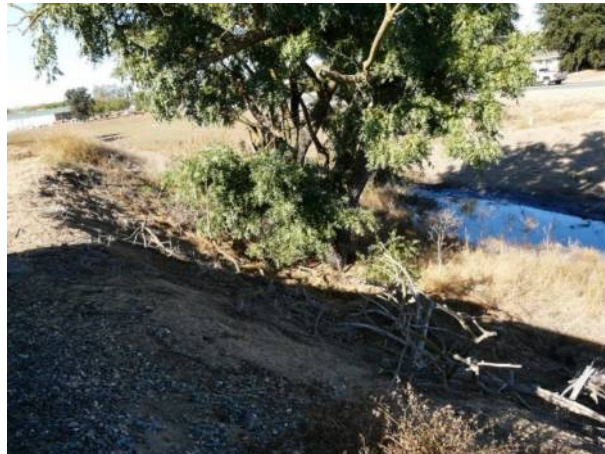
Levee Mile Report Line	8
Start Levee Mile	2.41
End Levee Mile	2.41
Location	Land Side
Category	Earthen Levee
Item	Trim / Thin Trees
Trim trees to provide visibility of landside of levee at LM 2.41.

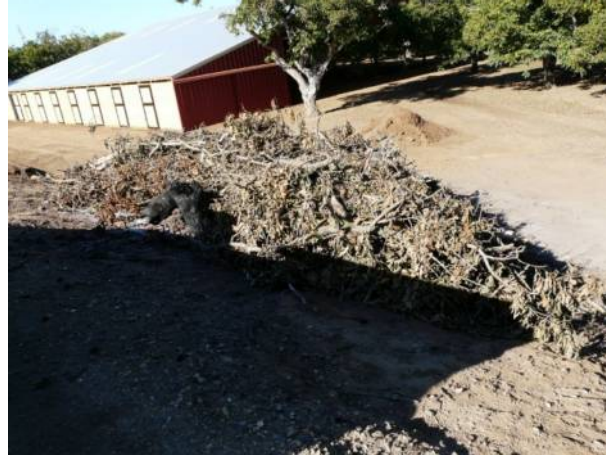
Levee Mile Report Line	11
Start Levee Mile	2.68
End Levee Mile	2.68
Location	Land Side
Category	Earthen Levee
Item	Encroachments
Remove prunings pile from landside of levee at LM 2.68.

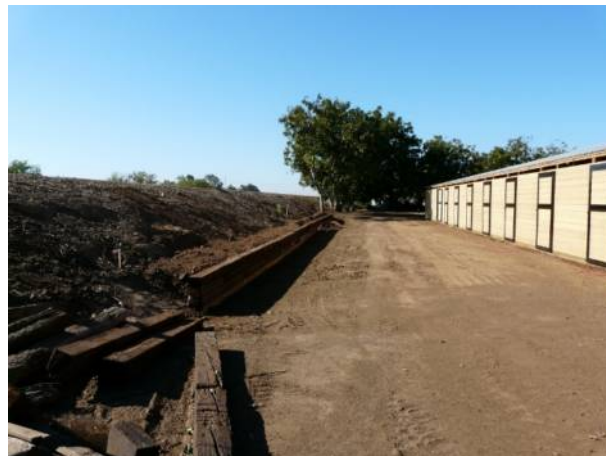
Levee Mile Report Line	12
Start Levee Mile	2.68
End Levee Mile	2.71
Location	Land Side
Category	Earthen Levee
Item	Encroachments
Recently built retaining wall at toe of landside levee at LM 2.68.

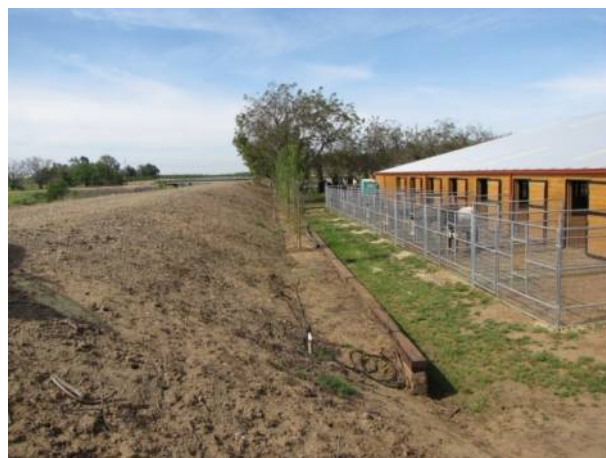
Levee Mile Report Line	12
Start Levee Mile	2.68
End Levee Mile	2.71
Location	Land Side
Category	Earthen Levee
Item	Encroachments
Updated view as of Spring 2009. Landscaping and irrigation has been added at the toe of the levee.

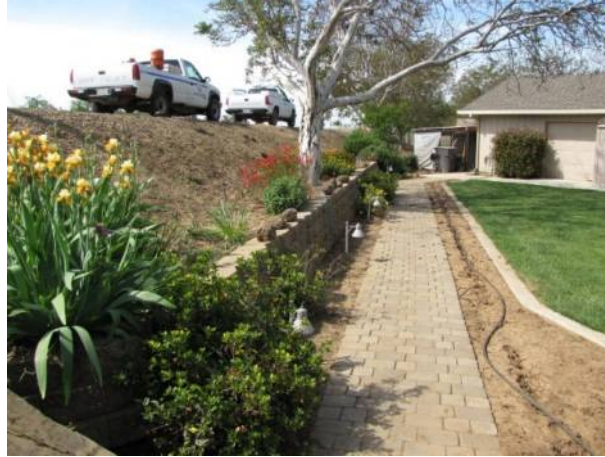
Levee Mile Report Line	15
Start Levee Mile	2.74
End Levee Mile	2.75
Location	Land Side
Category	Earthen Levee
Item	Encroachments

View of retaining wall and landscaping along the landward toe of the levee.

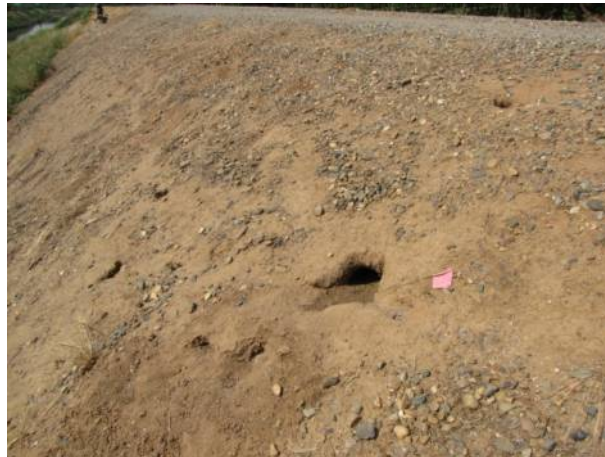
Levee Mile Report Line	29
Start Levee Mile	3.60
End Levee Mile	3.60
Location	Water Side
Category	Earthen Levee
Item	Animal Control

Example rodent hole in waterward slope of levee. There is some evidence of recent rodent activity.

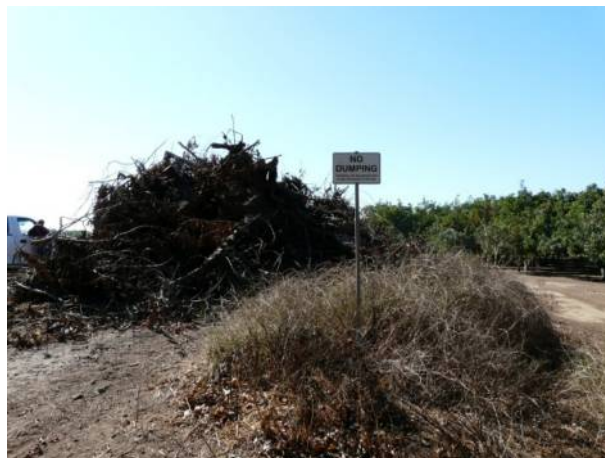
Levee Mile Report Line	39
Start Levee Mile	4.29
End Levee Mile	4.29
Location	Land Side
Category	Earthen Levee
Item	Encroachments

Example of a prunings pile immediately adjacent to access road at LM 4.29. Evidence of habitual burnings at this site.

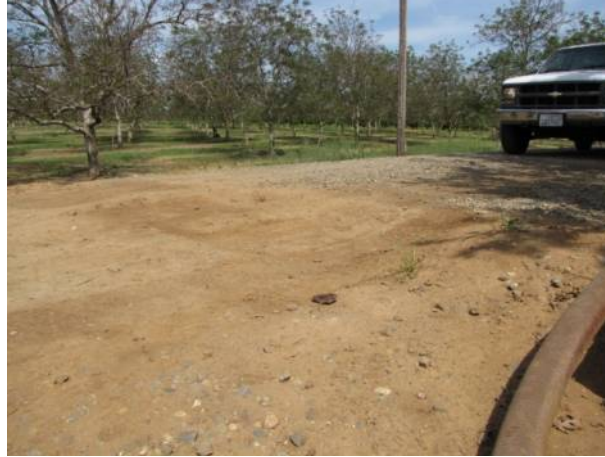
Levee Mile Report Line	43
Start Levee Mile	4.75
End Levee Mile	4.75
Location	Land Side
Category	Earthen Levee
Item	Crown Surface / Depressions / Rutting
Depression in roadway due to maintenance performed on a pipe penetration. The depression is a sign that the backfill material may not have been compacted properly. Recompect levee material and re-grade the levee crown.

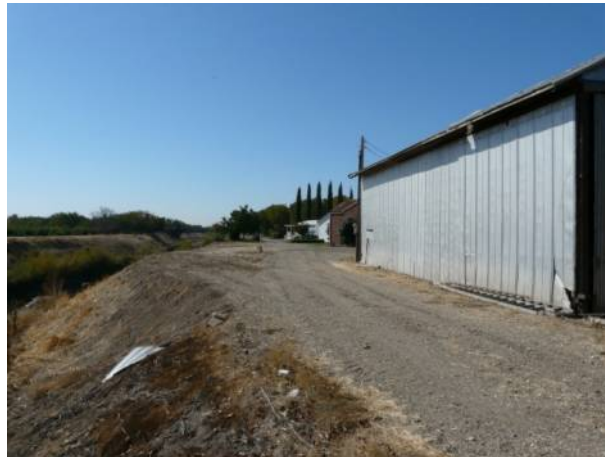
Levee Mile Report Line	51
Start Levee Mile	5.38
End Levee Mile	5.45
Location	Land Side
Category	Earthen Levee
Item	Encroachments
Building located immediately adjacent to access road approximately from LM 5.38 to 5.45

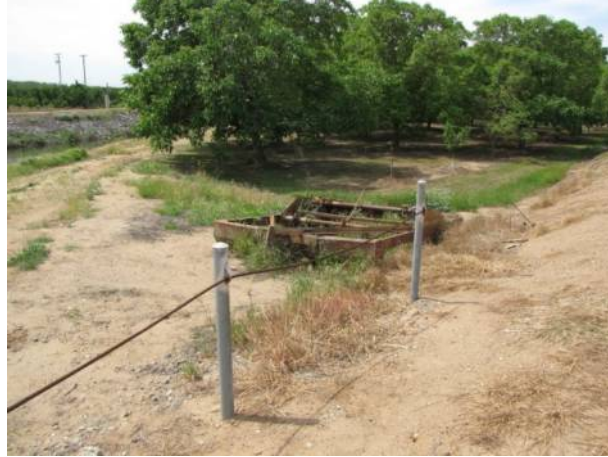
Levee Mile Report Line	63
Start Levee Mile	7.40
End Levee Mile	7.40
Location	Land Side
Category	Earthen Levee
Item	Encroachments
Move farmer's equipment 10' away from access road/levee.

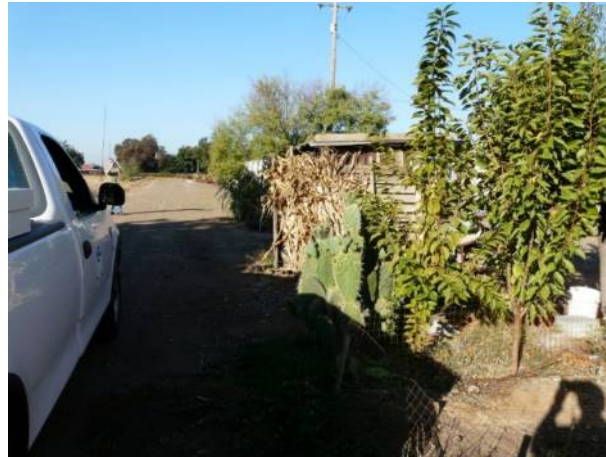
Levee Mile Report Line	81
Start Levee Mile	8.72
End Levee Mile	8.72
Location	Land Side
Category	Earthen Levee
Item	Encroachments
Building, fence and landscaping immediately adjacent to the access road at LM 8.72.

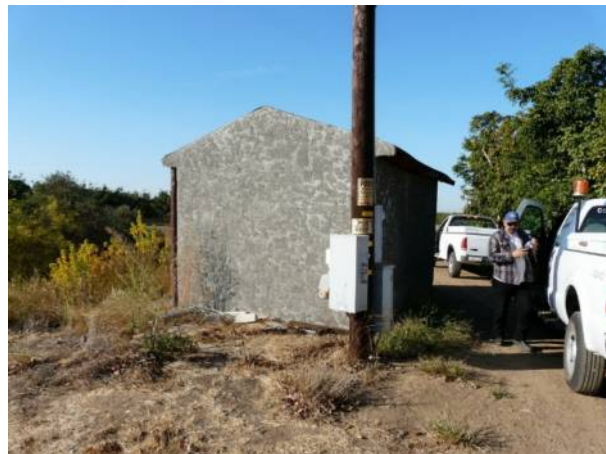
Levee Mile Report Line	85
Start Levee Mile	9.63
End Levee Mile	9.63
Location	Water Side
Category	Earthen Levee
Item	Encroachments
Building located at LM 9.63 on waterside of access road. This building appears to be recently constructed and does not currently contain anything.

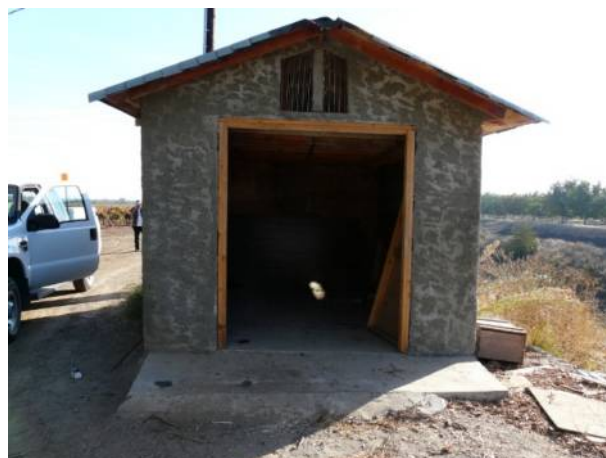
Levee Mile Report Line	85
Start Levee Mile	9.63
End Levee Mile	9.63
Location	Water Side
Category	Earthen Levee
Item	Encroachments
Additional view of building at LM 9.63.

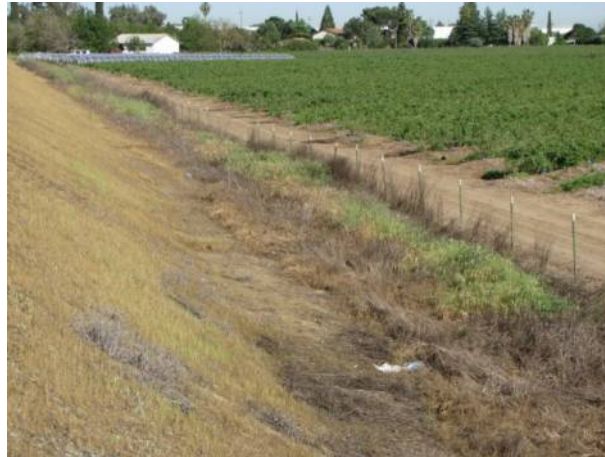
Levee Mile Report Line	107
Start Levee Mile	15.49
End Levee Mile	15.75
Location	Land Side
Category	Earthen Levee
Item	Vegetation
Remove/mow vegetation and grass within 10' of levee toe.

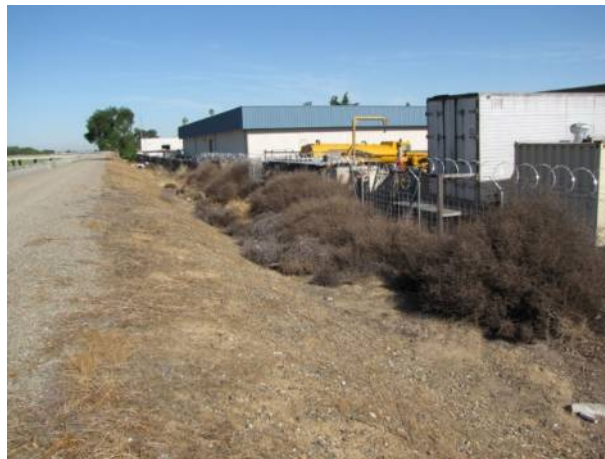
Levee Mile Report Line	109
Start Levee Mile	17.02
End Levee Mile	17.02
Location	Land Side
Category	Earthen Levee
Item	Vegetation
Remove vegetation within 10' of landward toe of levee.

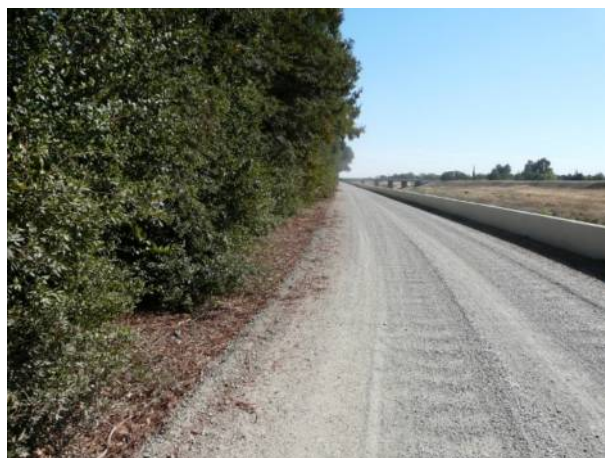
Levee Mile Report Line	111
Start Levee Mile	17.83
End Levee Mile	18.04
Location	Land Side
Category	Earthen Levee
Item	Trim / Thin Trees
Trim trees from LM 17.83 to LM 18.04 to at least 5 feet from levee surface to allow visibility and ability to conduct flood fight.

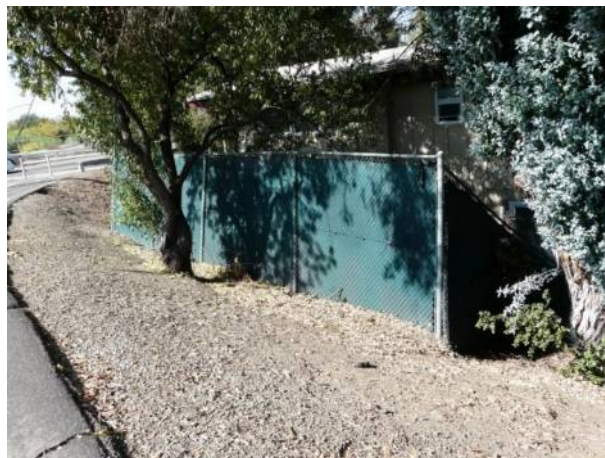
Levee Mile Report Line	122
Start Levee Mile	22.36
End Levee Mile	22.37
Location	Land Side
Category	Earthen Levee
Item	Encroachments

Fence located from LM 22.36 to LM 22.37 significantly encroaches onto landside levee slope.

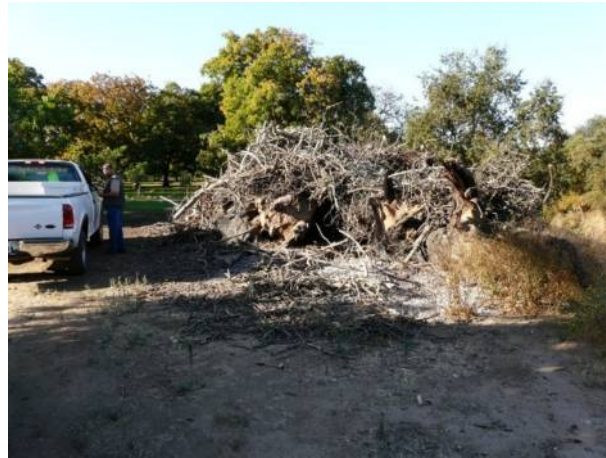
Levee Mile Report Line	1
Start Levee Mile	0.32
End Levee Mile	0.32
Location	Crown
Category	Earthen Levee
Item	Encroachments
Prunings pile located at LM 0.32 on waterside shoulder of access road. The pile impedes access and forces vehicles to drive through orchard.

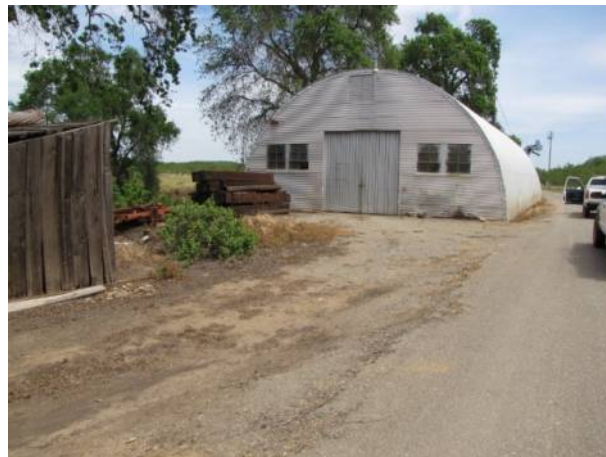
Levee Mile Report Line	2
Start Levee Mile	0.54
End Levee Mile	0.54
Location	Water Side
Category	Earthen Levee
Item	Encroachments
Building/shed and other equipment located on waterward side of access road. There is no vehicle access adjacent to the channel.

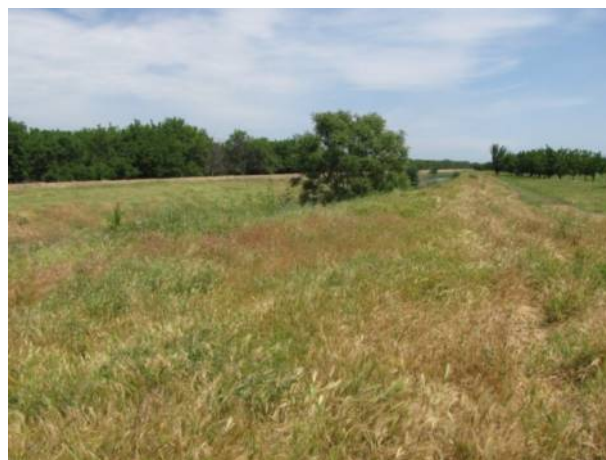
Levee Mile Report Line	6
Start Levee Mile	2.79
End Levee Mile	3.28
Location	Crown
Category	Earthen Levee
Item	Vegetation
Remove/mow vegetation along crown of levee/access road.

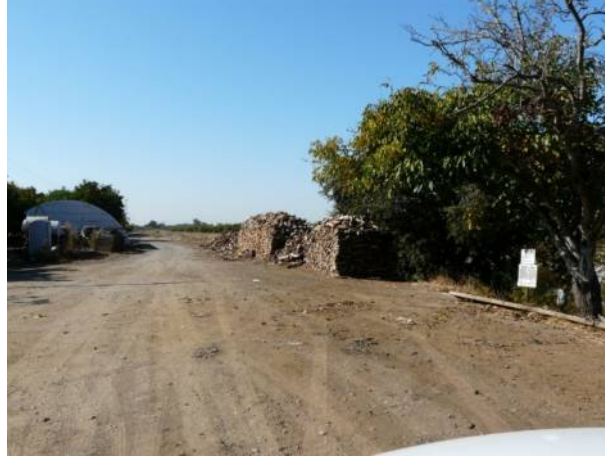
Levee Mile Report Line	13
Start Levee Mile	5.95
End Levee Mile	5.95
Location	Water Side
Category	Earthen Levee
Item	Encroachments

Firewood piles located on waterside of shoulder at LM 5.95. These piles should be moved away from landside of access road.

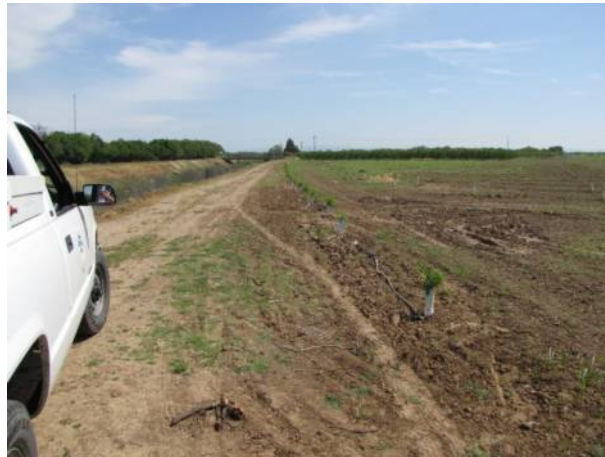
Levee Mile Report Line	16
Start Levee Mile	7.11
End Levee Mile	7.29
Location	Land Side
Category	Earthen Levee
Item	Encroachments

Recently planted trees are within 10' of landward toe of levee. These trees are an encroachment and are potentially future maintenance issues.

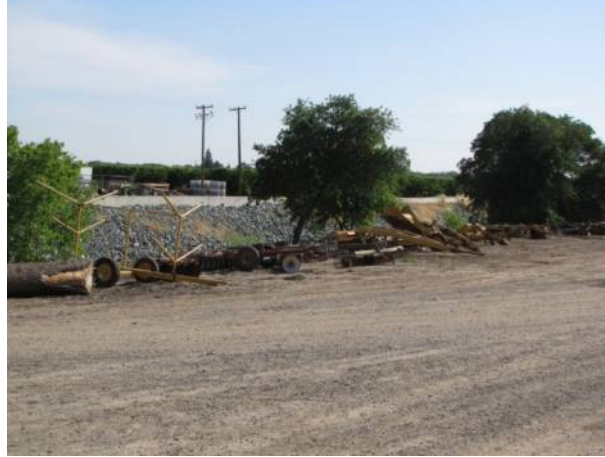
Levee Mile Report Line	31
Start Levee Mile	11.58
End Levee Mile	11.58
Location	Land Side
Category	Earthen Levee
Item	Encroachments
Remove equipment from waterward side of levee.

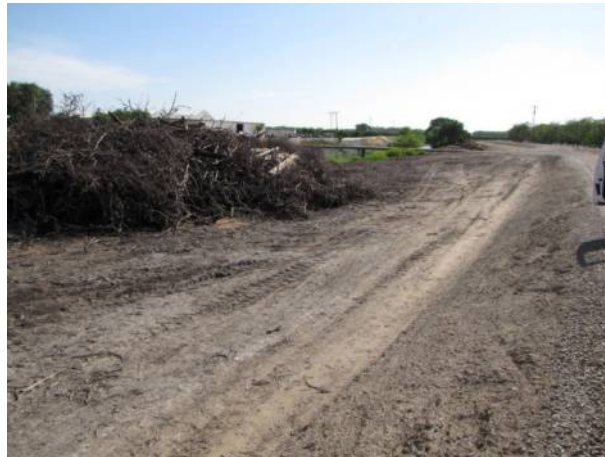
Levee Mile Report Line	32
Start Levee Mile	11.64
End Levee Mile	11.64
Location	Water Side
Category	Earthen Levee
Item	Encroachments
Remove prunings along waterward portion of levee.

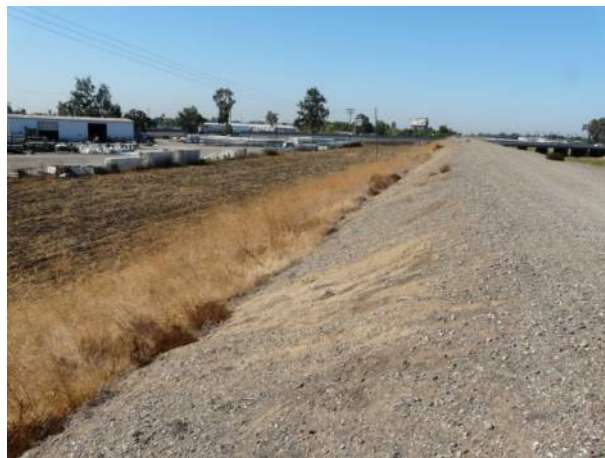
Levee Mile Report Line	38
Start Levee Mile	16.38
End Levee Mile	16.41
Location	Land Side
Category	Earthen Levee
Item	Vegetation
Remove/mow vegetation to 10' from landside toe to maintain visibility from LM 16.38 to LM 16.41 and LM 16.46 to LM 16.65.

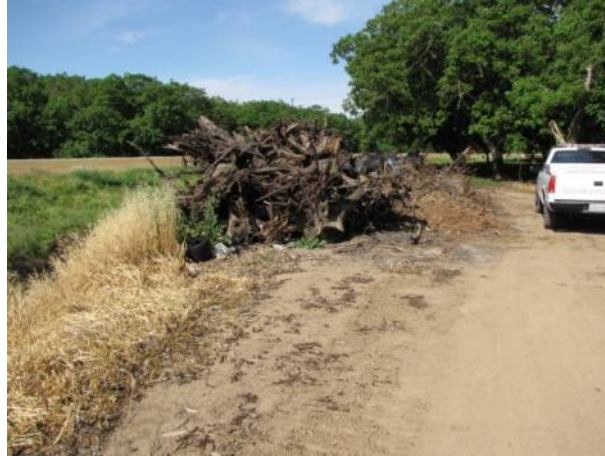
Levee Mile Report Line	1
Start Levee Mile	0.50
End Levee Mile	0.50
Location	
Category	Earthen Levee
Item	Encroachments
Debris pile located on waterside of levee at LM 0.50.

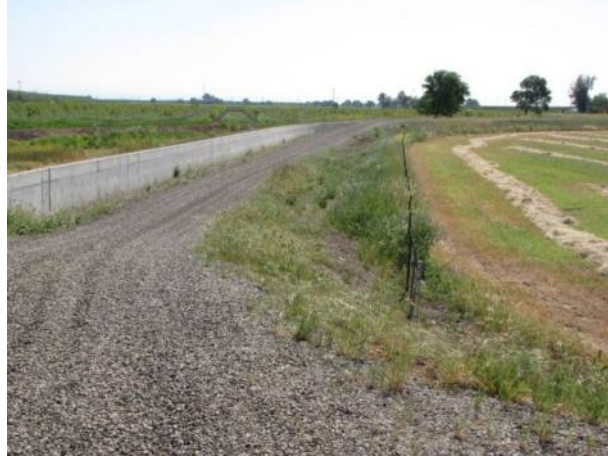
Levee Mile Report Line	1
Start Levee Mile	0.10
End Levee Mile	0.50
Location	Land Side
Category	Earthen Levee
Item	Vegetation
Control annual grass & weeds along landside of levee from LM 0.10 to LM 0.50.
